Manhole Inspection Summary

Manhole # S35Q__013MH

Insp Date: **2/12/08 12:02 PM**

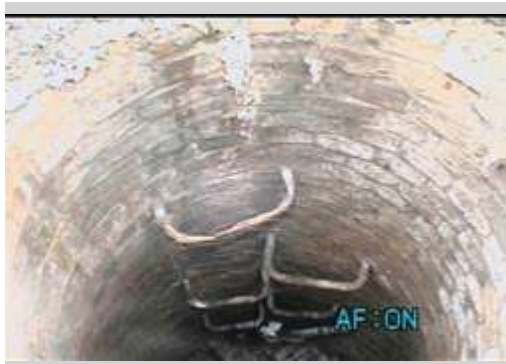
Defect 1

Count: **7** Missing: **1** ☒ **Corroded**

corroded/missing steps

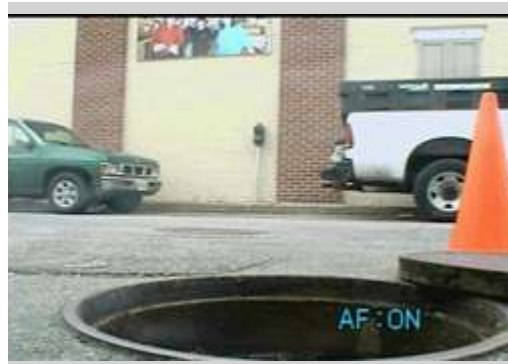
Defect 2

Diameter: **32** (in.) Length: **0** (in.) Dist A/B Grade: **1** (in.)

cover above pavement

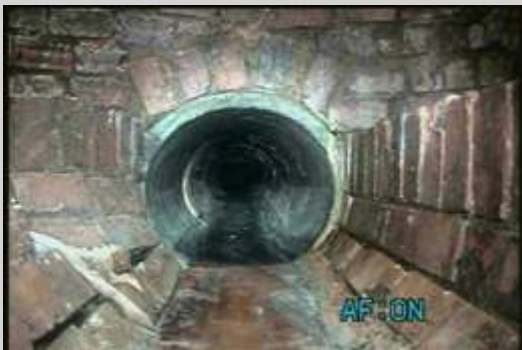
12 O'Clock Outflow

12 in. Circular Gravity Sewer
Pipe Out @ 12 O'Clock

Pipe Material: **Clay** ☐ Pipe Lined

Invert Depth: 11.40 (ft.) Flow Characteristics: **Fast**

Deposits: ☒ None ☐ Mud ☐ Sludge ☐ Debris ☐ Grease

Infiltration: **None** Pipe Seal Cond: **Unknown**

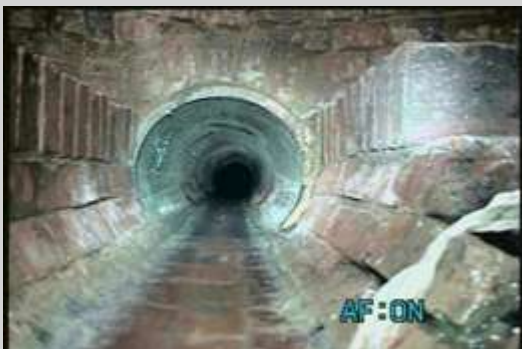
6 O'Clock Inflow

12 in. Circular Gravity Sewer
Pipe In @ 6 O'Clock

Pipe Material: **Clay** ☐ Pipe Lined

Invert Depth: 11.30 (ft.) Flow Characteristics: **Fast**

Deposits: ☒ None ☐ Mud ☐ Sludge ☐ Debris ☐ Grease

Infiltration: **None** Pipe Seal Cond: **Unknown**

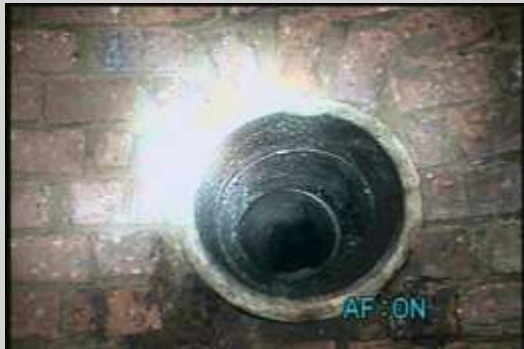
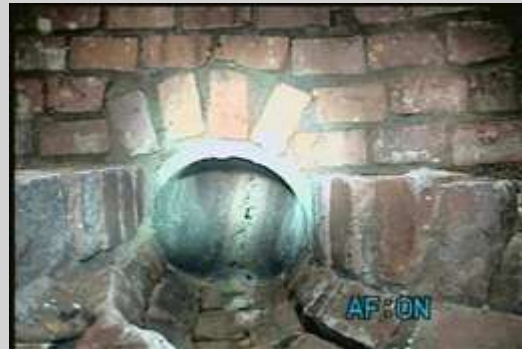
9 O'Clock Inflow

8 in. Circular Gravity Sewer

Pipe In @ 9 O'Clock

Drop In @ 9 O'Clock

Pipe Material: **Clay** ☐ Pipe Lined

Invert Depth: **8.90** (ft.) Flow Characteristics: **Slow**

Drop: **Inside** **Direct**

Inv Depth: **11.20** (ft.)

Drop Condition: **Open**
